# **A Proof Of Principle Nuclear Forensics Technique for Determining $^{235}\text{U}$ Enrichment from $\text{UF}_6$ Steel Cylinders**

**Master of Applied Science**

**Nuclear Engineering**

Department of Energy and Nuclear Engineering  
University of Ontario Institute of Technology (Ontario Tech University)

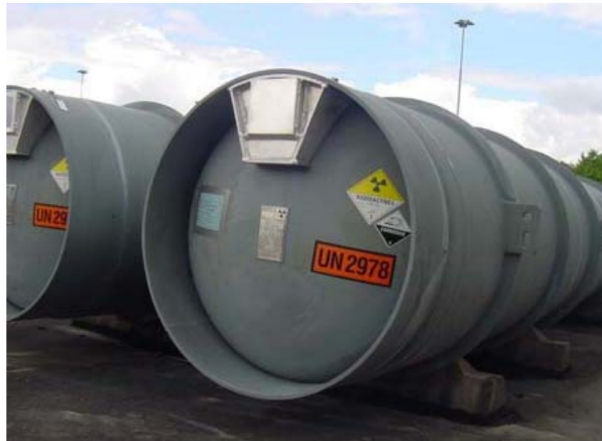
Figure 1.2: Photograph of a 48Y cylinder used to store  $\text{UF}_6$  [14]. Dimensions of a 48Y cylinder are: 150" in length with a diameter of 48".

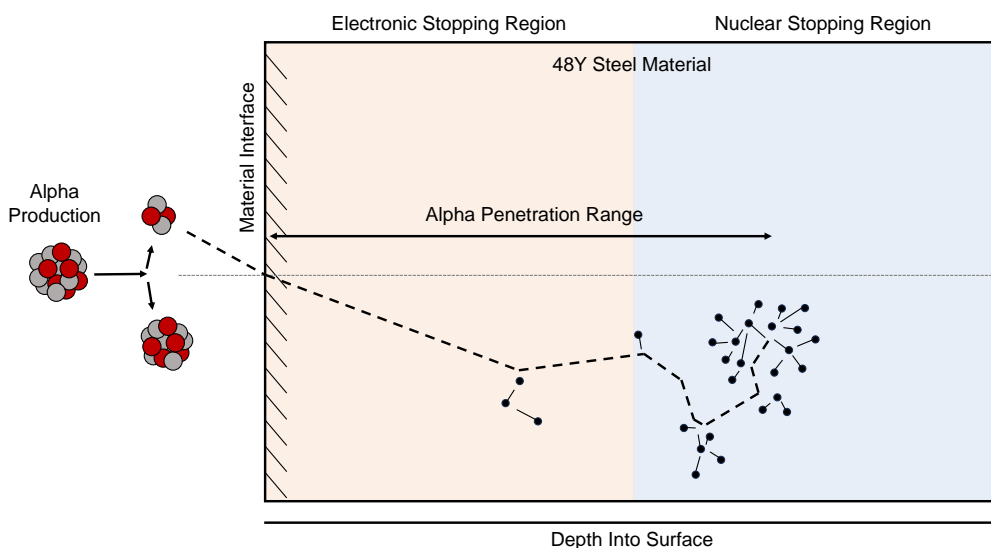
Figure 3.1: Representation of how an  $\alpha$  particle will interact with the outer surface of the material. The particle will initially undergo electronic stopping before losing enough energy to undergo nuclear stopping, before coming to rest.

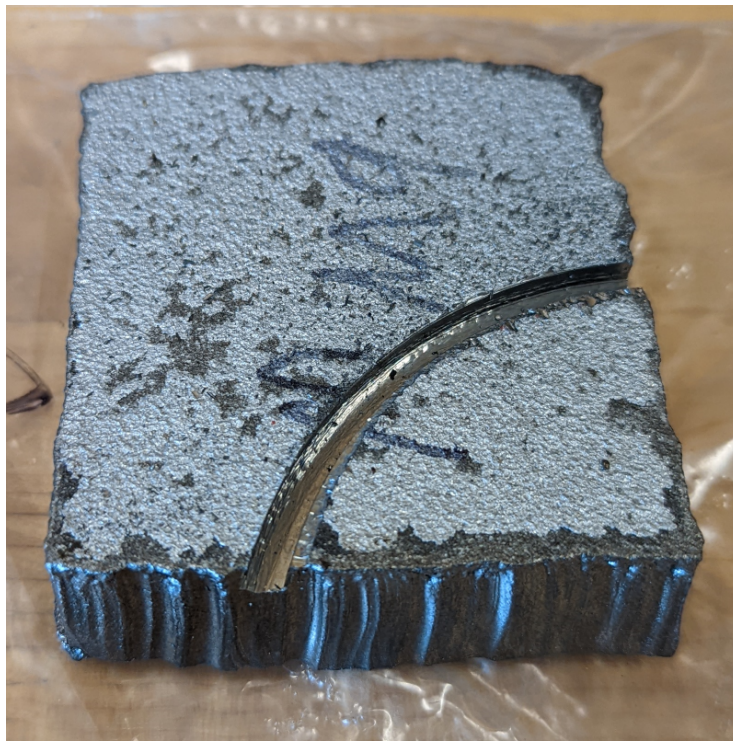
Figure 5.2: Photograph of small sand blasted sample after test cuts were made. The sample was difficult to cut through, and was stopped after it was decided high power equipment was required.

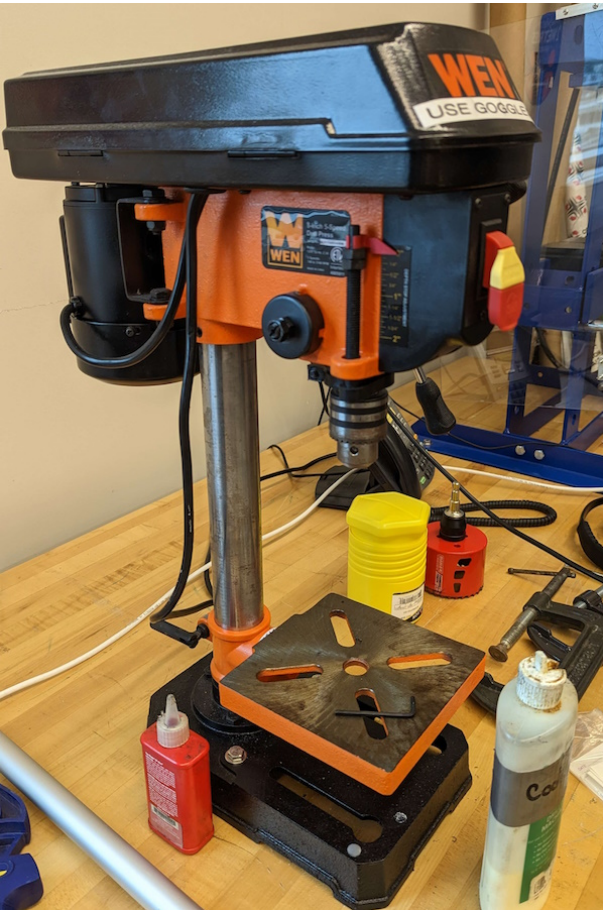
Figure 5.3: Photographs of drill presses used for this work.

(a) Smaller drill press initially used for test cuts.

(b) Larger RIDGID drill press used for cutting of samples.

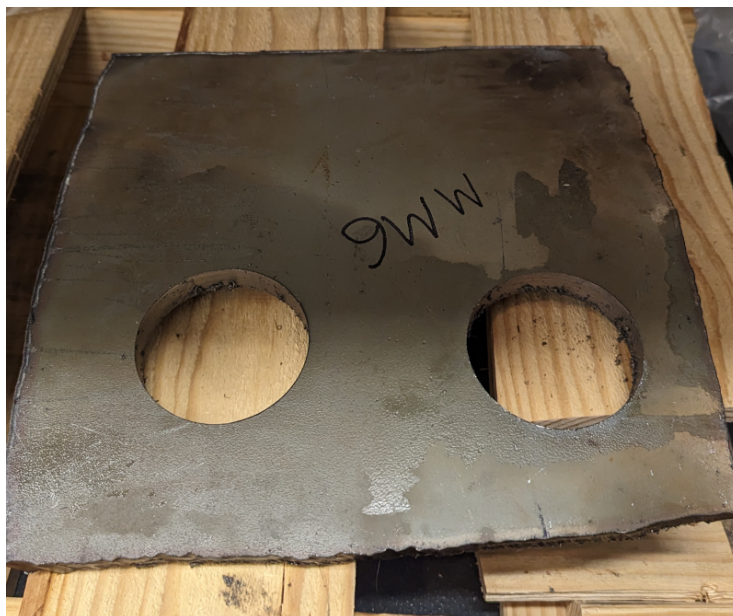
Figure 5.4: Photograph of full sample as received from Cameco Corporation with two cut out holes. Four plates were received, two large (18" x 18"), and two small (12" x 12").

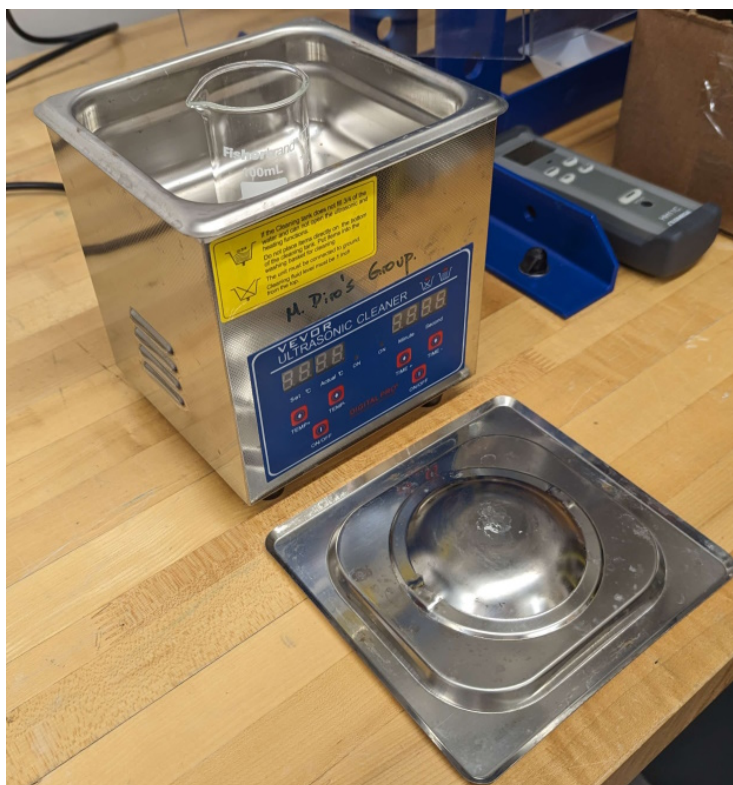
Figure 5.7: Photograph of Vevor Ultrasonic Cleaner used in this work for sample cleaning.

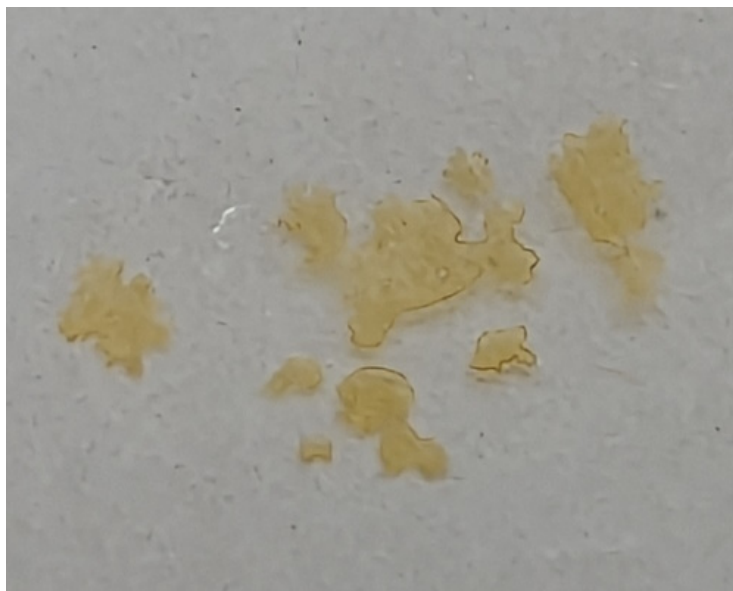
Figure 5.9: Image of dissolved material after cleaning within de-ionized water.

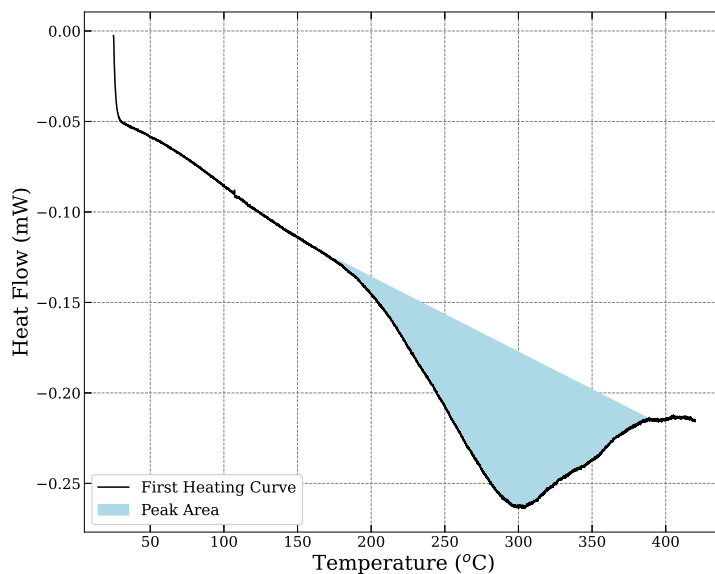
Figure 5.16: Overview of peak isolation from first heating curve. Various fit types were tested with minimal differences between final outputs.

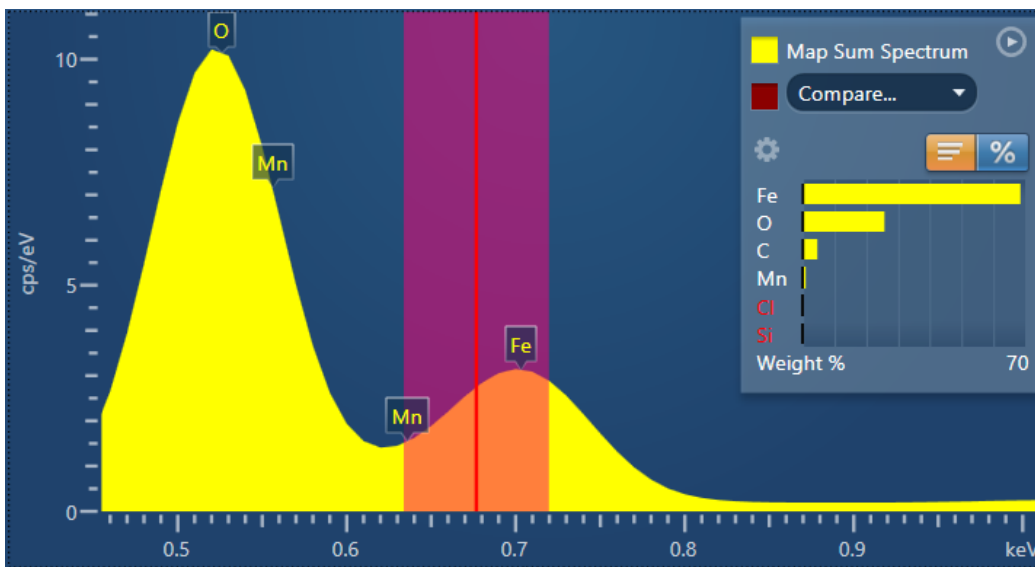
Figure 6.16: EDS output for sample 7A-1-1, indicating the overlap between Fe and F for EDS purposes. The overlap makes it difficult to reliably detect F in Fe rich materials.

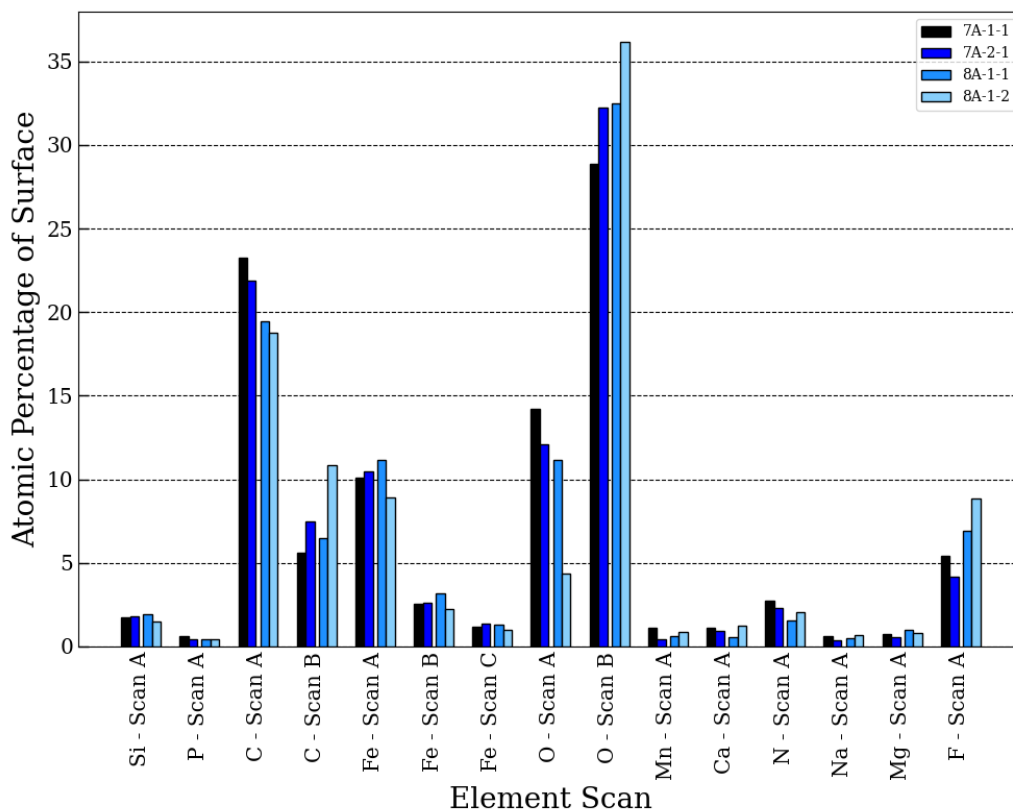
Figure 6.17: Atomic percentages of each elemental scan, indicating relative percentage across samples. Most elements remained consistent, with oxygen, carbon and fluorine indicating the biggest disparities.

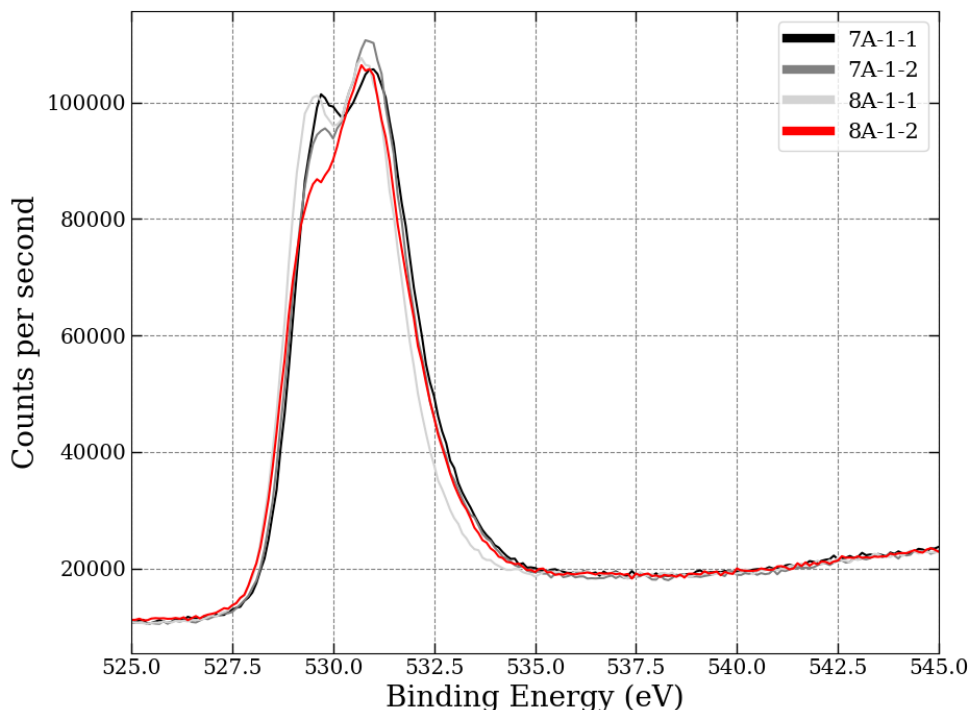
Figure 6.18: XPS scans relating to O composition. Sample 8A-1-2 indicated a much lower composition for scan A.

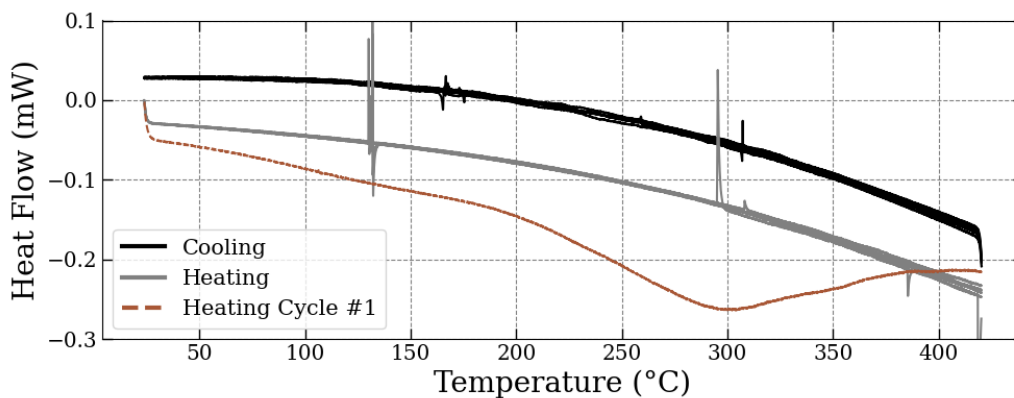
Figure 6.28: FlashDSC results from the 50 °C/s experiment, indicating the difference in first heating curve from the following heating and cooling curves.

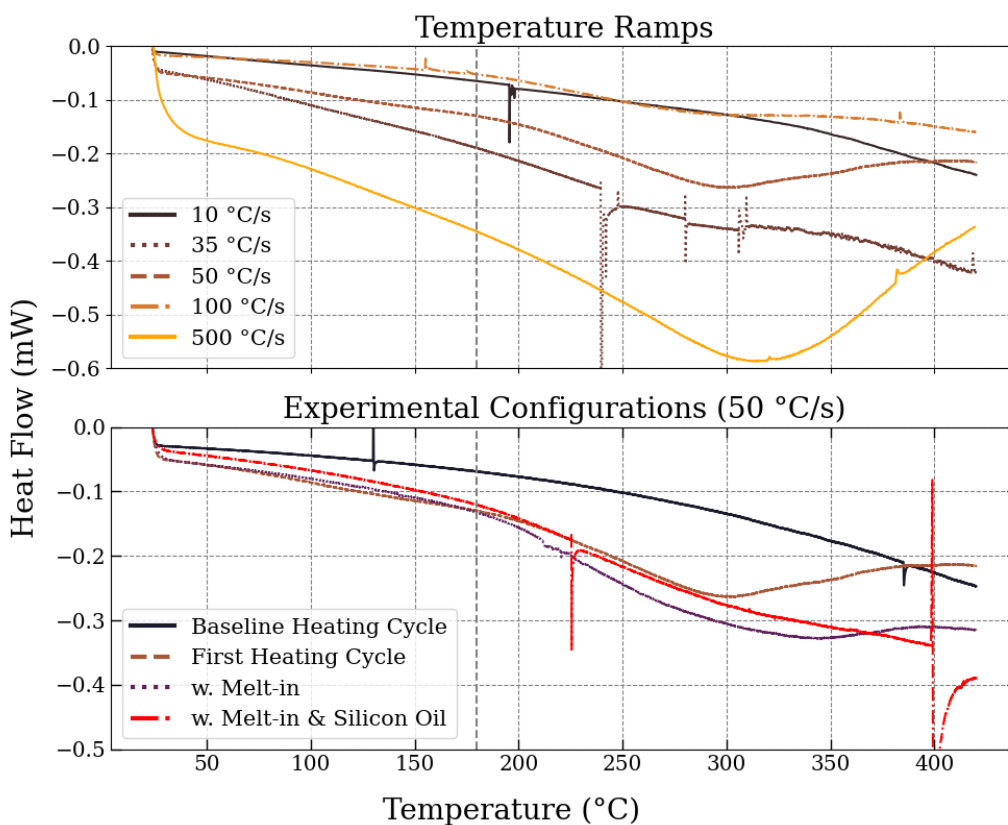
Figure 6.29: FlashDSC results from the various experimental methodologies utilized to both confirm realness of the first curve, and identify optimal conditions. The first curves were found to be consistent for a stable heating rate, with a slightly changed tail based on use of silicon oil.

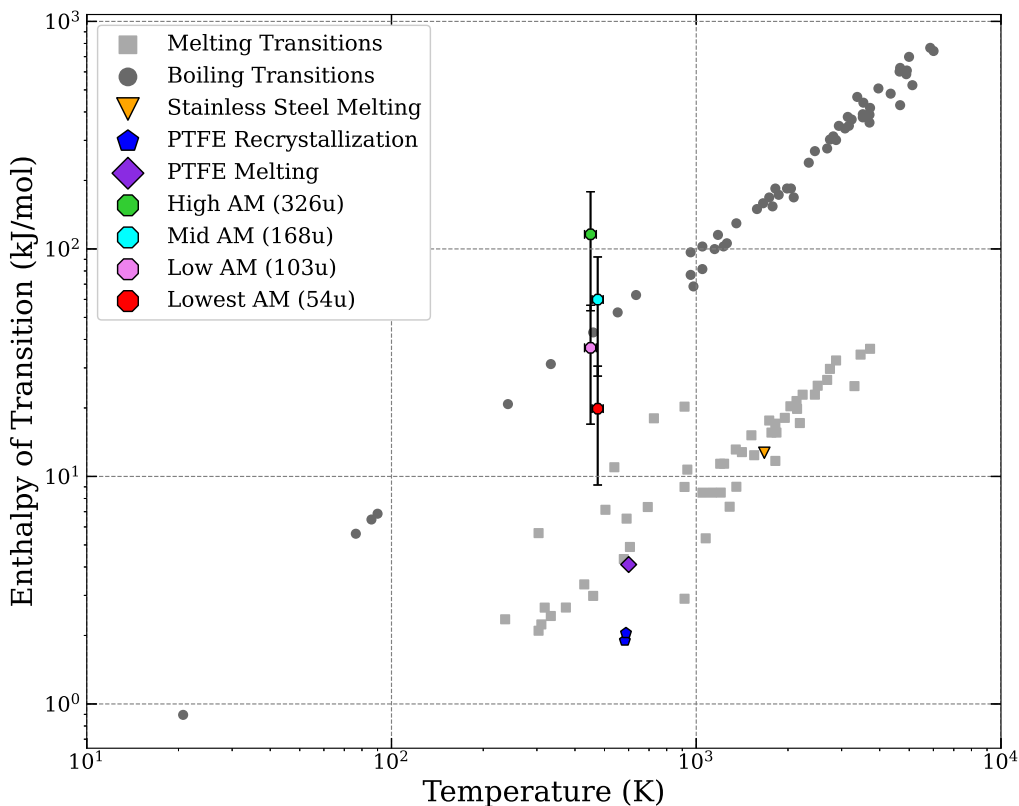
Figure 6.30: Comparison of determined potential energy ranges to melting and boiling phase transitions, as well as previous literature for stainless steel transitions, and PTFE re-crystallization after irradiation [15, 51–53].
